Chapter 3: The Gold Cup

Stuart Needham

General condition and problems

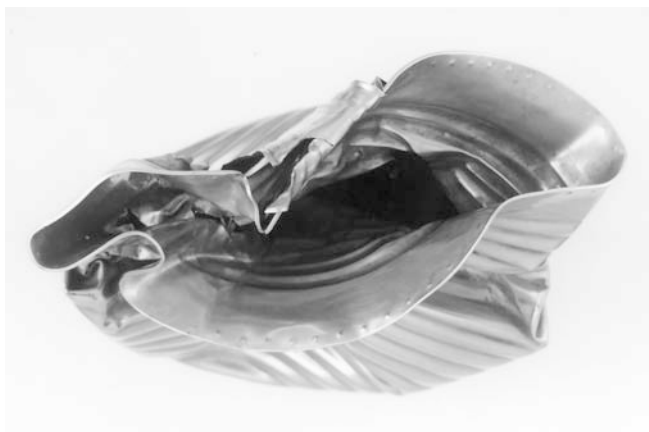
Plate 3 Top view showing crushing of the mouth

It is probable that the main blow and the opposing resistance, which nearly pinched together part of the middle of the body, also accounts for the flattening of the upper body roughly into a narrow pointed ellipse (**Pl. 3**). At the two ends of this ellipse the rim and neck have been crushed on a near-vertical axis into acute angles. The remainder of the circumference features other more or less severe buckles interspersed with seemingly more intact stretches. The stresses involved have acted unevenly causing the sheet metal to fold at a limited number of points on the circumference. The stretch of wall inside the handle has been partially flattened, the handle itself having been pressed up against it and almost folded double towards the top (**Pl. 4**). A tear runs half way across this fold, and there is a further substantial tear across the lower end where it joins the carination because the handle has been pulled upward in the process of being crushed (**Colour Pl. 2**).

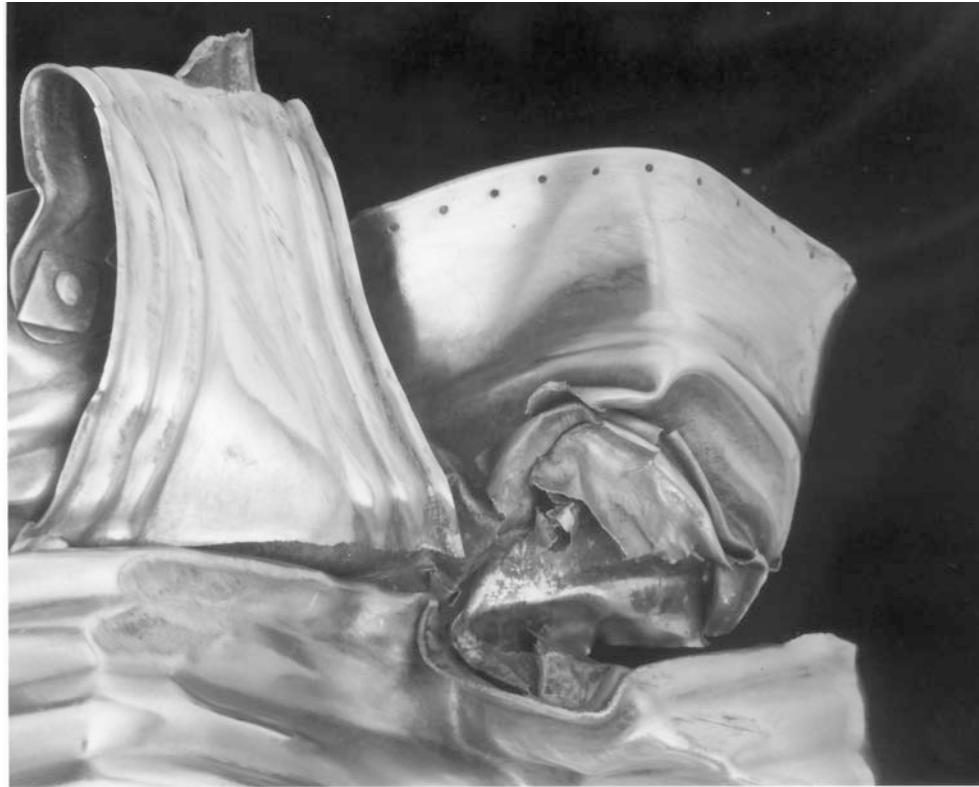
Plate 5 Detail of gash in side of body

Another substantial blow has caused damage of different character. It has badly gashed the side of the vessel to the right

of the handle base (**Pl. 5**). The metal immediately around the gash shows marked but local crumpling on both faces and part of a rectangular impression has been left on one edge.

A series of coarse parallel striations aligned diagonally on the handle are clearly secondary (**Pl. 5**). They are limited to the flattened central stretch in between the double bend at top and a slight bend towards the bottom, hence formed at the time of the crushing, or subsequently.

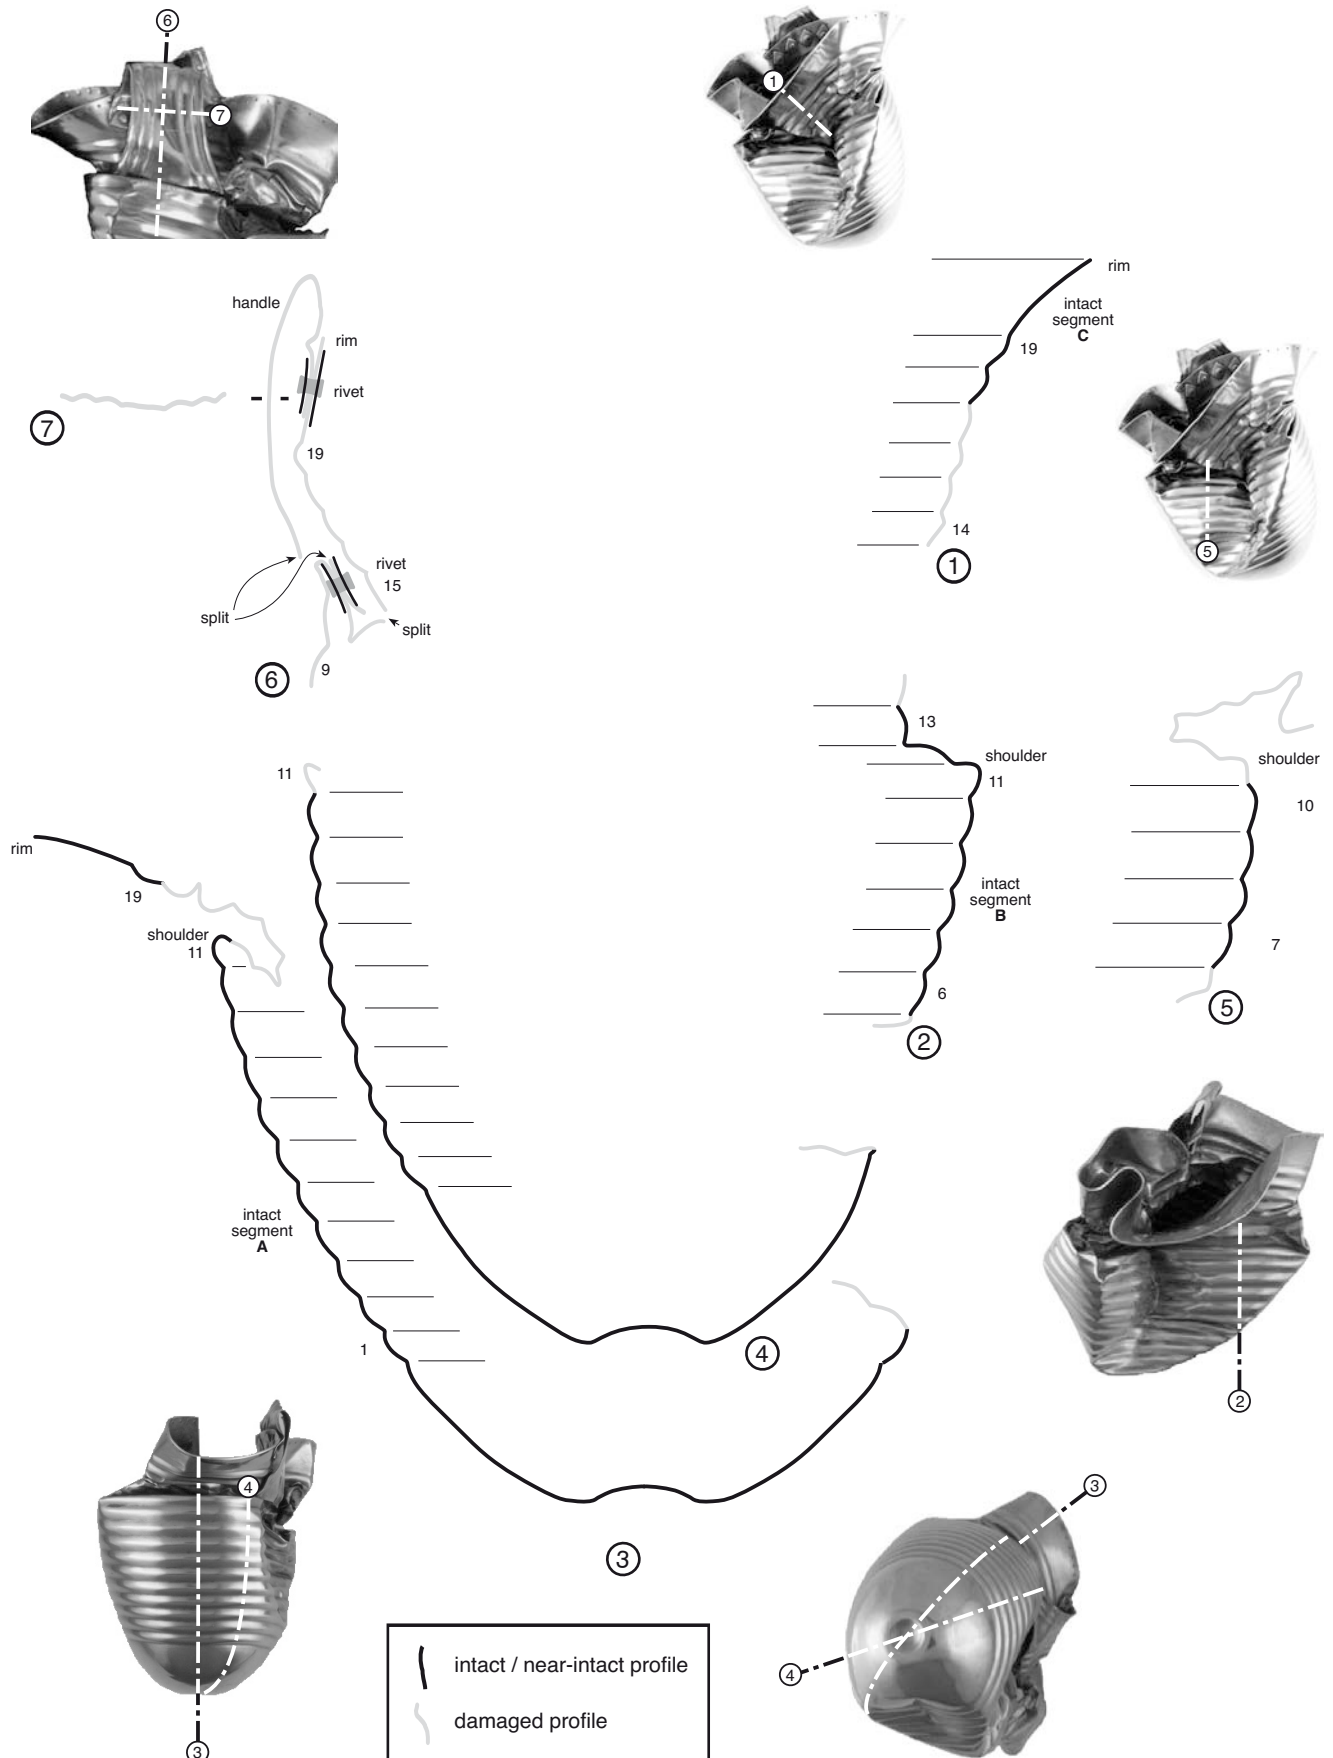
Figure 22 Drawn profiles of the crushed vessel at selected points (scale 100%)

Intact segment A: The first is obvious – one side of the lower body running all the way from the base up to rib 11. The profile (Fig. 22; Pl. 6) must be very close to the original even though there may be slight distortion of some radii due to the severe damage to either side. As a double-check on radii, circumferences were measured around ribs 1 and 11, a process made difficult by the deep cleft in the front of the body.

in addition to the smoothly cusping profile of ribs 6–10 of the lower body, it shows the profile to turn at rib 11 and continue at a new angle for ribs 12 and 13 before any significant distortion intervenes (Fig. 22; Pls 7 & 8). What this segment shows beyond any doubt is that the middle of the cup was not the weak or

moderate carination familiar on its parallels. Instead the upper body turns suddenly inward at rib 11 producing a shoulder occupied by ribs 12 and 13. The shoulder is sloped, forming an angle of about 110° with the body below and thus nearer to the horizontal than the vertical. The presence of this strong

Intact segment C: Fortunately the third segment encompasses part of the rim and extends down through the smooth band and then ribs 19 and 18 before some flattening or buckling of ribs 17 onwards (Fig. 22; Pl. 9). This segment is not pristine, but undulations are minor and the broad form unlikely to be much altered. It gives a good basis for the angle at which the rim stood and the profile of the upper neck. Although difficult due to the severe contortions, it was possible to obtain circumference measurements at the rim itself and on rib 19 and thus a reliable reconstruction of the mouth of the cup.

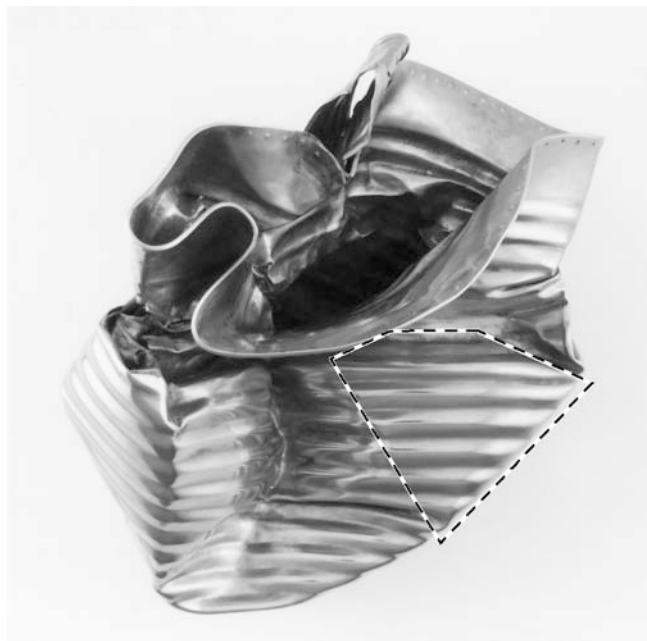
Plate 7 Face view of intact segment B (outlined)

Intact segment B: A smaller segment situated within one side of the pronounced cleft is somewhat surprisingly intact. This was not at first appreciated, but is of enormous significance because

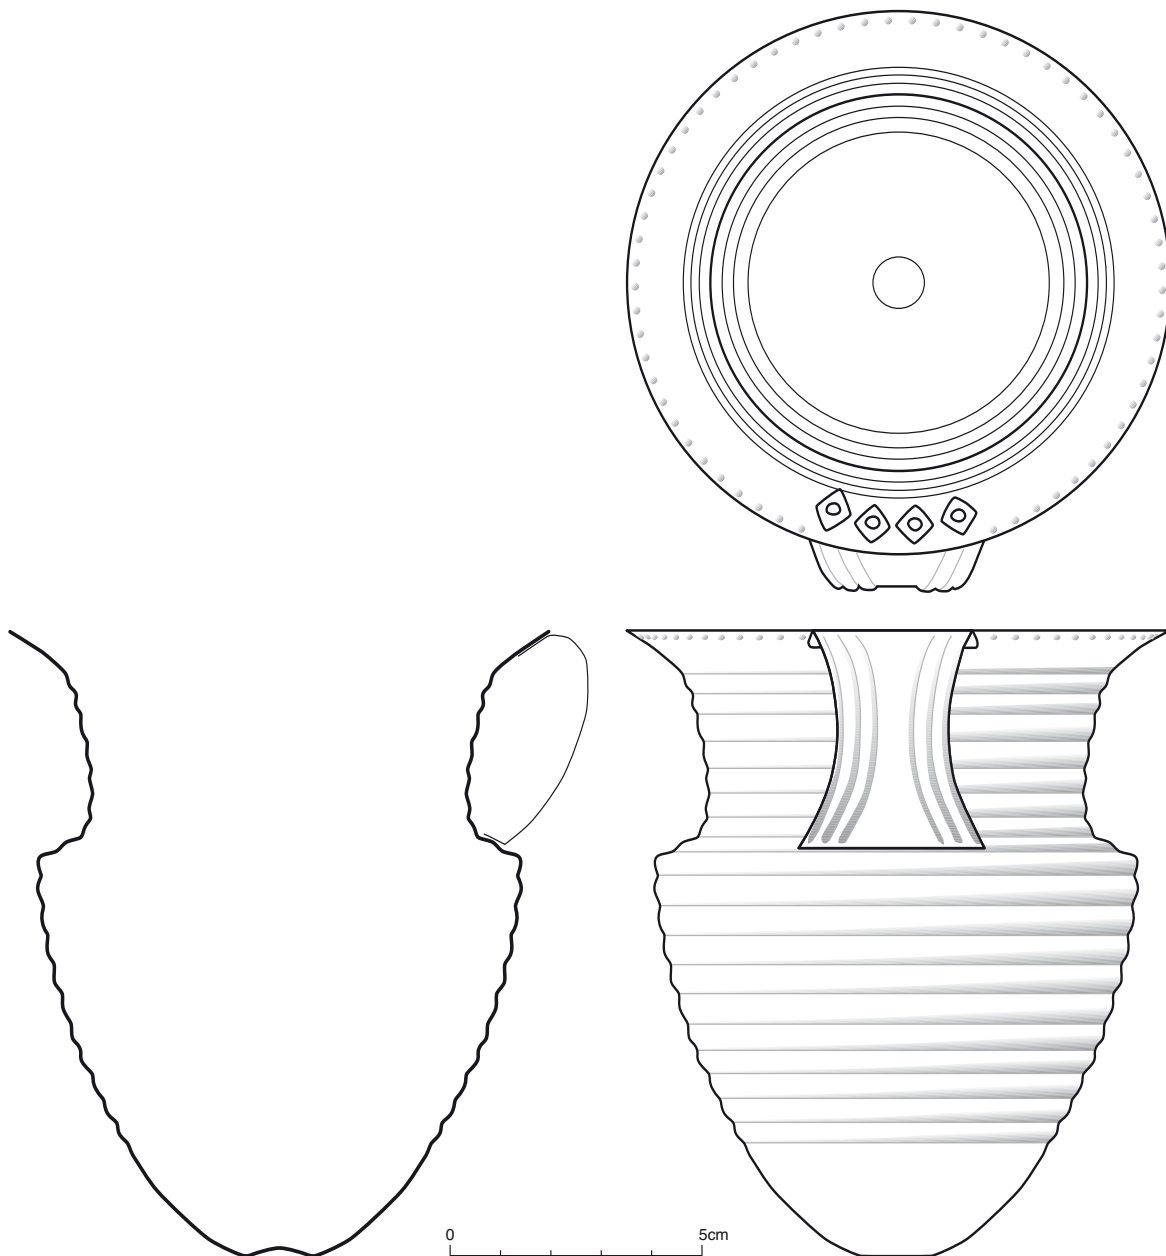
Figure 23
Reconstruction drawing of the Ringlemere cup (scale 67%)

The Ringlemere cup would have stood around 123mm tall, the greater part, 78mm, being the lower body to the shoulder (Fig. 23). The diameter at the shoulder was 96mm, that at the neck a minimum of about 76mm and at the rim 109mm. It currently weighs 183.7g, which should be close to the original weight since very little if any metal has been removed at the gash. Further dimensions, both measured and calculated, are given in the catalogue.

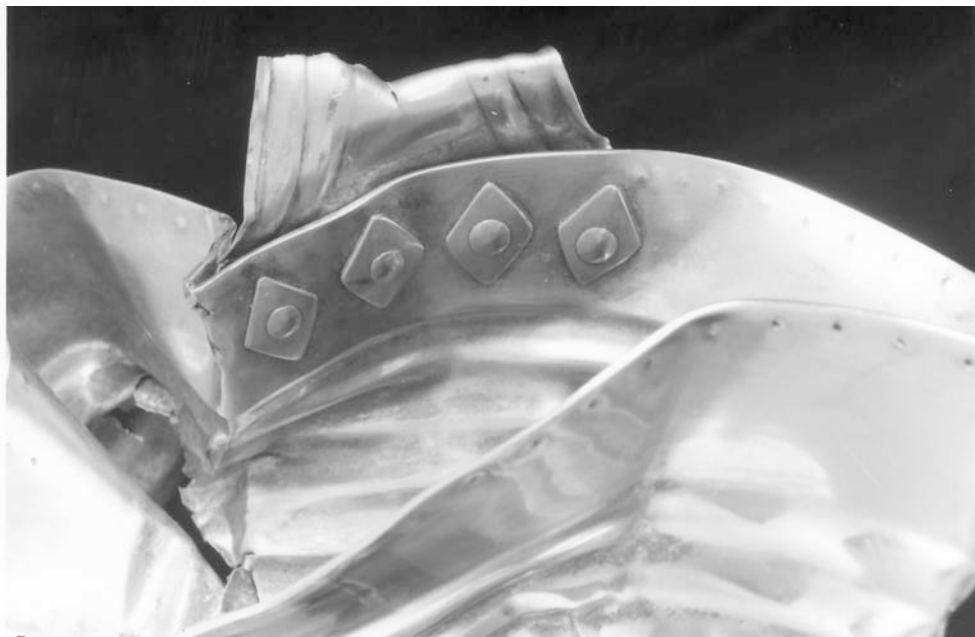
Plate 10 Detail of the inner upper rivet fixings

For the top fixing, the nature of the riveting is easily observed inside the vessel (Pl. 10), but for the outside the crushing of the handle means that only the outermost rivets are really visible. The lower fixing is much more difficult to view. The collapse of the shoulder on this side of the cup has taken the tab down into the tight double fold. Very little of the outside

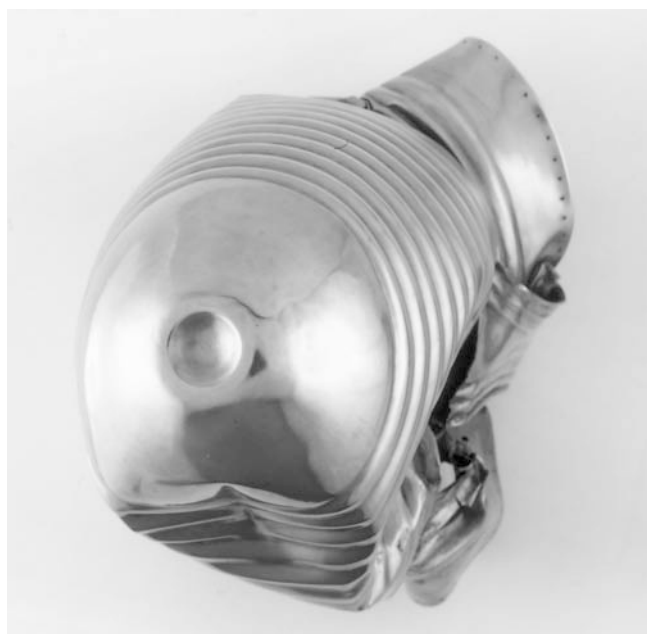
Plate 12 Detail of base showing the omphalos

The image presented by the Ringlemere cup is striking partly because of the obvious quality of the original workmanship, but also because of the severe crumpling it has suffered (**Colour Pls 1 & 2**). The greater part of the damage appears to be due to impacts of similar nature – heavy blows with a hard, pointed object or objects. The most swinging blow was received to the middle of the side opposite the handle at or just below the carination, leaving this side with a deep cleft. Diametrically opposite is a lesser dent just below the handle, presumably arising from resistance to this impact. Because of the rigidity of the corrugated conical lower body the main cleft has caved in as a roughly triangular shape with crisp surrounding arrises. To the right of it the original morphology is little affected, but to the left of the cleft there is another lesser dent, again with a linear central crease running vertically up the body. This is the only significant damage to encroach on the uncorrugated, basal part of the body (**Pl. 12**).

The omphalos is still very neat in outline and profile (**Pl. 12**). Its surround shows two possible patches of wear in diametrically opposing segments, but these are so slight as to be of uncertain significance. Other subtle dents and creases around the unribbed zone are side effects of the major damage or, in some cases perhaps, original hammer marks not fully planished out.
